# Case Study

BALANCED MACHINES

## Solve Reclaimer Pantograph Cracking

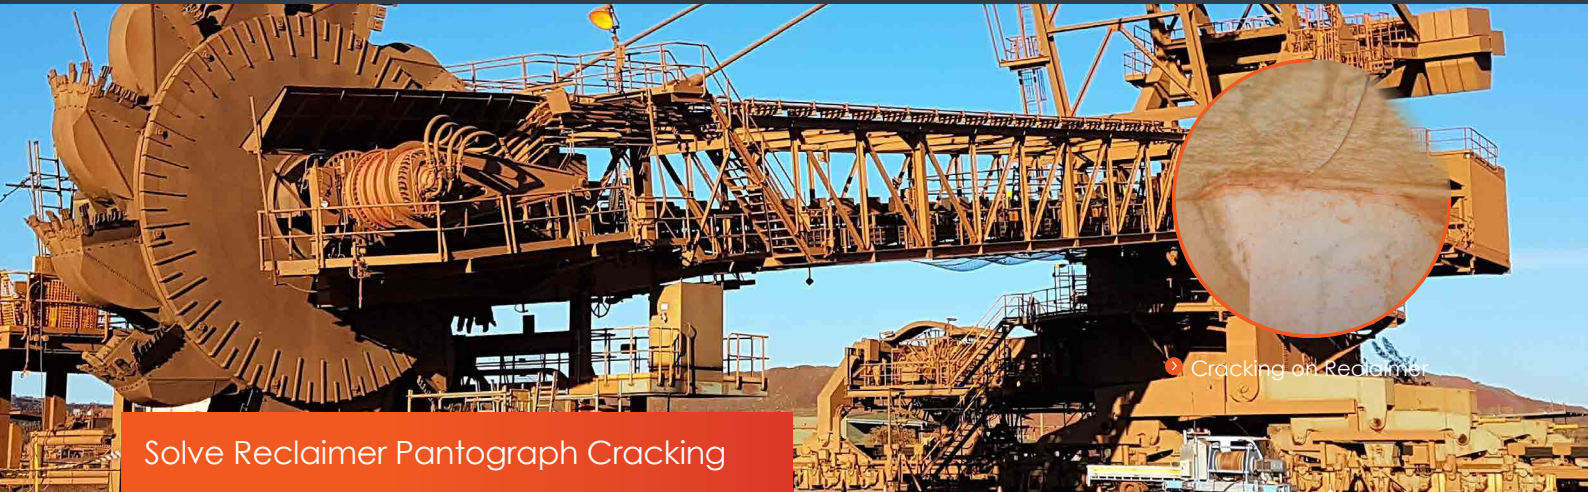
Adra identified cracks at the connection of the pantograph structure to the luffing cylinders during a routine inspection.

The machine OEM proposed a modified gusset profile and Adra analysed the repair original design and repair to verify the changes. The analysis predicted the cracking, confirming it was the result of a design flaw. Adra delivered a modified gusset designed to lower the stress concentration, provide a uniform stress distribution and improve the load transfer from the gusset to the pantograph mounting beam.

Through Adra's advocacy the OEM implemented the repair under warranty using the improved gusset design.

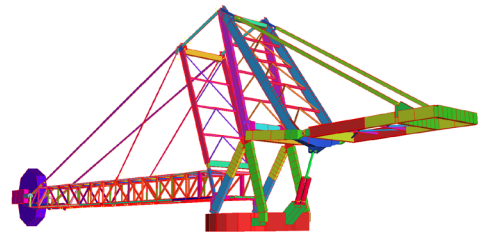
Reclaimer FEA model

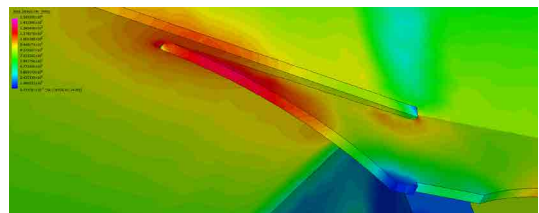
FEA model of Adra designed gusset
